An NCC Group Publication

Porting the Misfortune Cookie Exploit: A Look into Router Exploitation Using the TD-8817

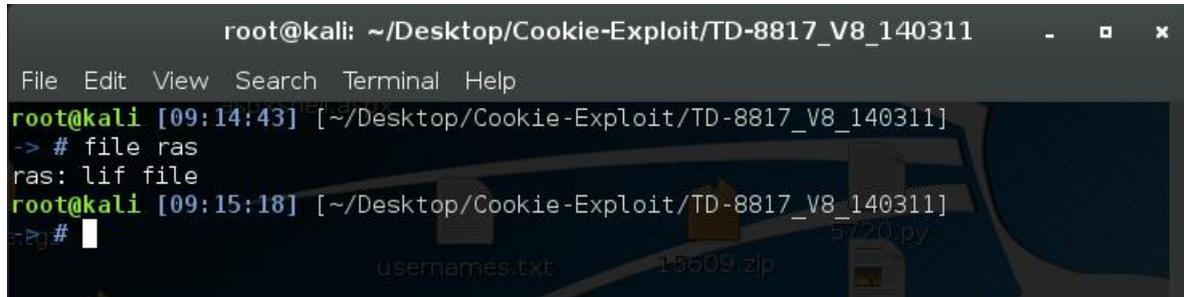
The firmware for the TD-8817 comes prepackaged as a zip archive. Within this you will find two files: a PDF describing how to install the update on the router, and a file simply named "ras". The "ras" file is the one we are interested in. Transfer this file over to your Linux machine and install binwalk if you haven't already. The first thing we need to do is see what type of file we are dealing with. Let's see if the **file** command returns anything:

```
root@kali: ~/Desktop/Cookie-Exploit/TD-8817_V8_140311
File Edit View Search Terminal Help
root@kali [09:14:43] [~/Desktop/Cookie-Exploit/TD-8817_V8_140311]
-> # file ras
ras: lzf file
root@kali [09:15:18] [~/Desktop/Cookie-Exploit/TD-8817_V8_140311]
-> #
```

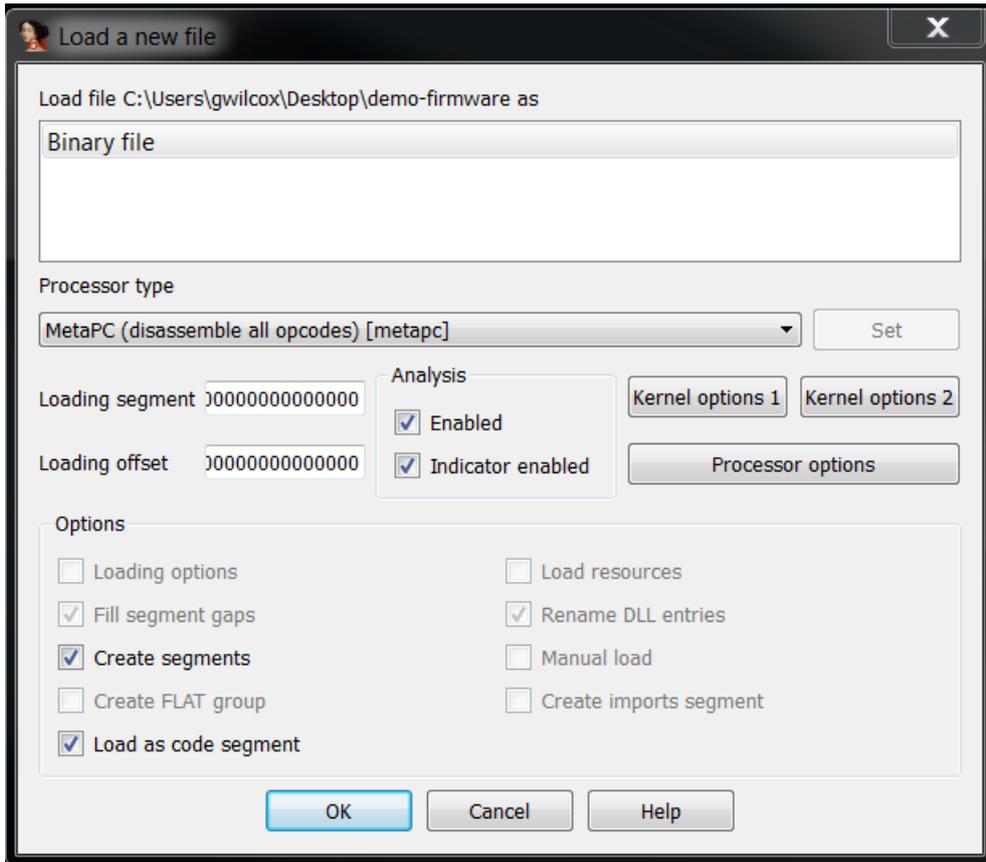
This article revealed that the MIPS32_M14K CPUs are a set of 32-bit cores/CPUs from MIPS which use the fairly new microMIPS instruction set, not the MIPS32 instruction set we had been trying to use earlier. The microMIPS instruction set aims to take the existing MIPS32 instruction set and shrink the corresponding code size down by as much as thirty per cent by using shorter instructions to perform the same tasks. IDA must be reconfigured to disassemble the firmware using the microMIPS instruction set, rather than the MIPS32 instruction set, before it can properly analyse the firmware. To do this, we will first load the firmware into IDA Pro, which should return a screen that looks something like the following screenshot:

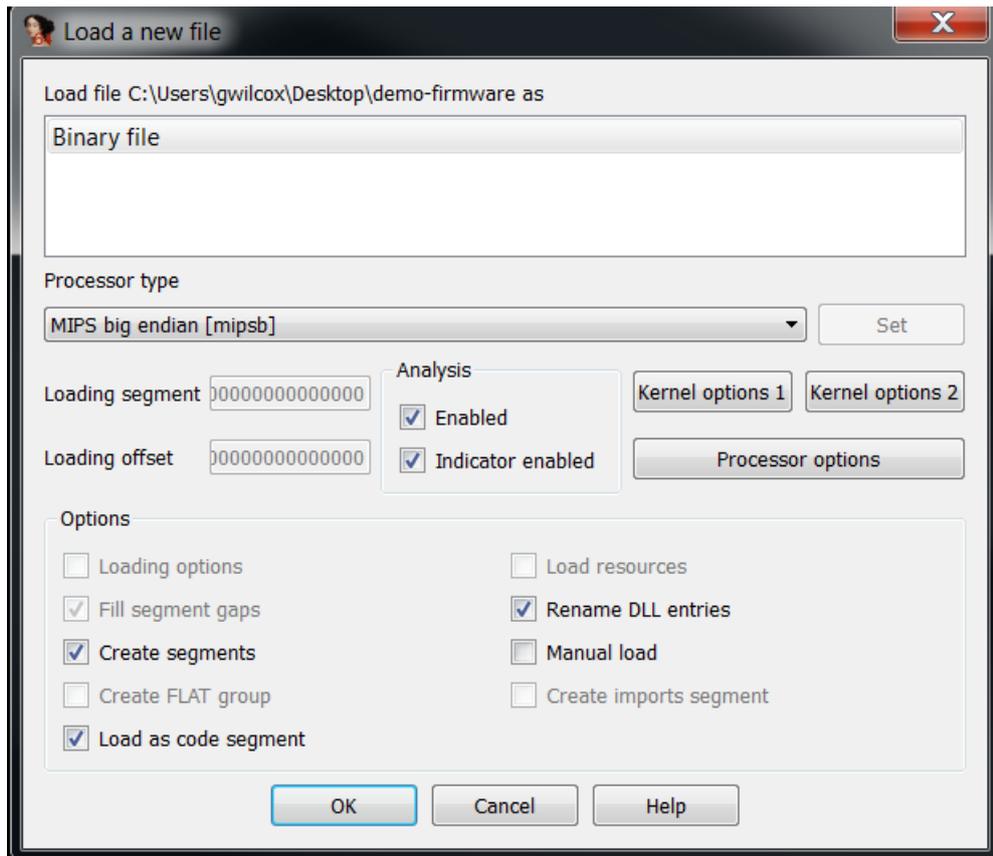
Once you get to this page, the first thing that you will want to do is change the processor type to MIPS by clicking on the dropdown menu under "Processor type" and selecting "MIPS big edian [mipsb]", then clicking the "Set" button to the right of this menu, and OK on the alert box that appears. When done your screen should look like this:

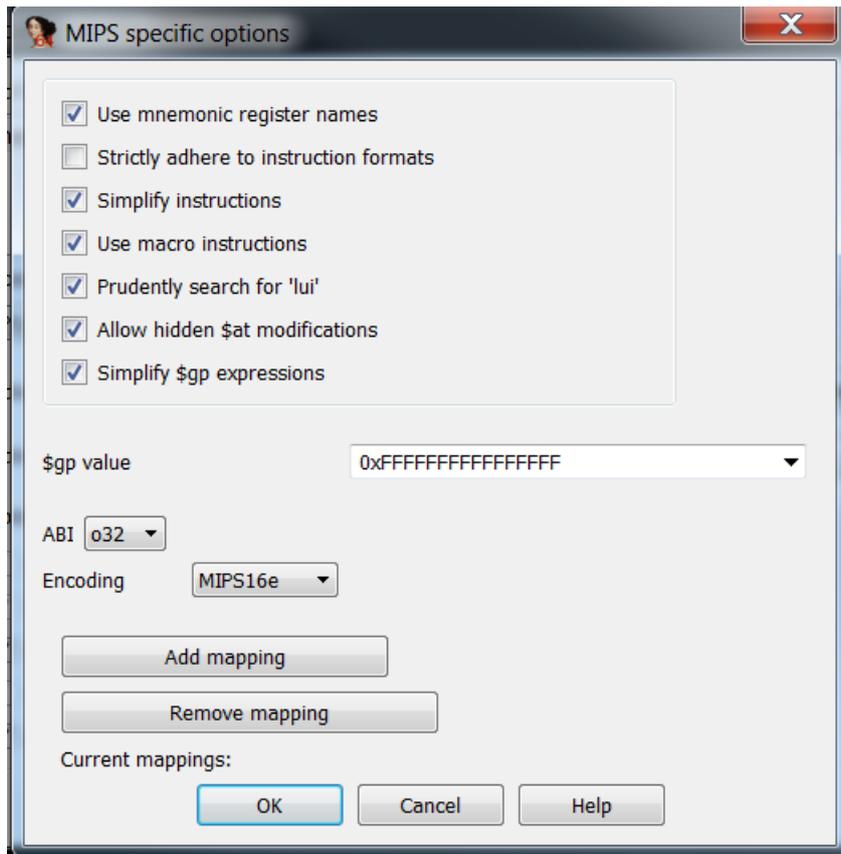
Now that we have told IDA that we are going to be loading a binary from a big-endian MIPS processor, we need to tell it to not use the MIPS instruction set, but rather microMIPS. To do this, first click on the button titled "Processor options". You should get the following screen:

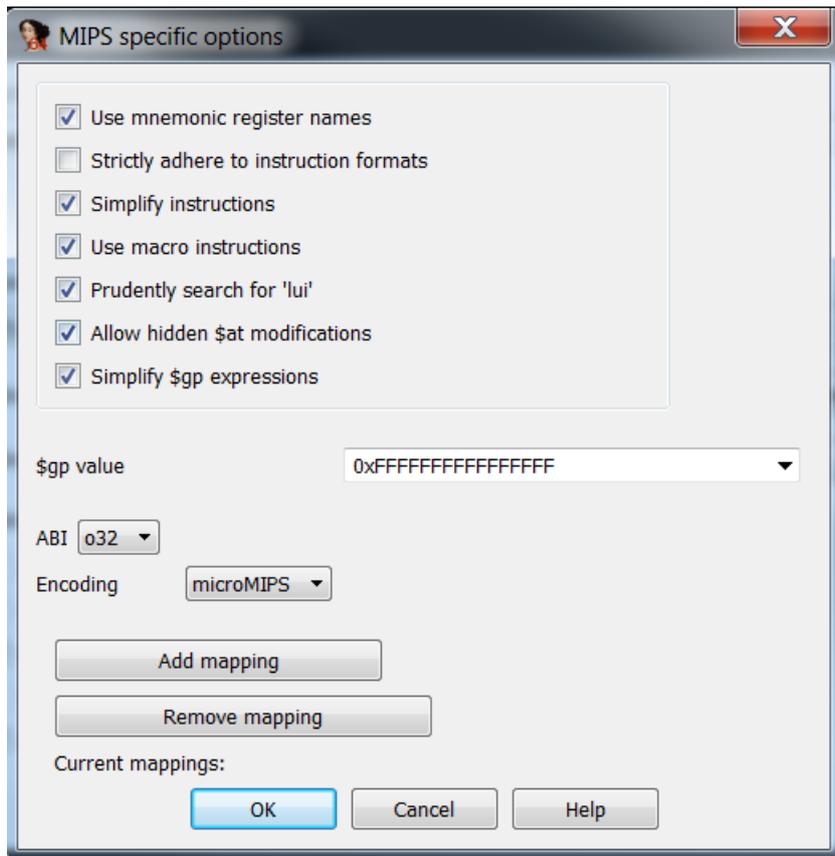
If you look under “Encoding”, we can see that we are currently using the instruction set “MIPS16e”. If we click on this dropdown menu we can see that there is an option to set this to “microMIPS”. Set the encoding to “microMIPS” using this menu, and press OK. For reference the screen should look like this before you press OK:

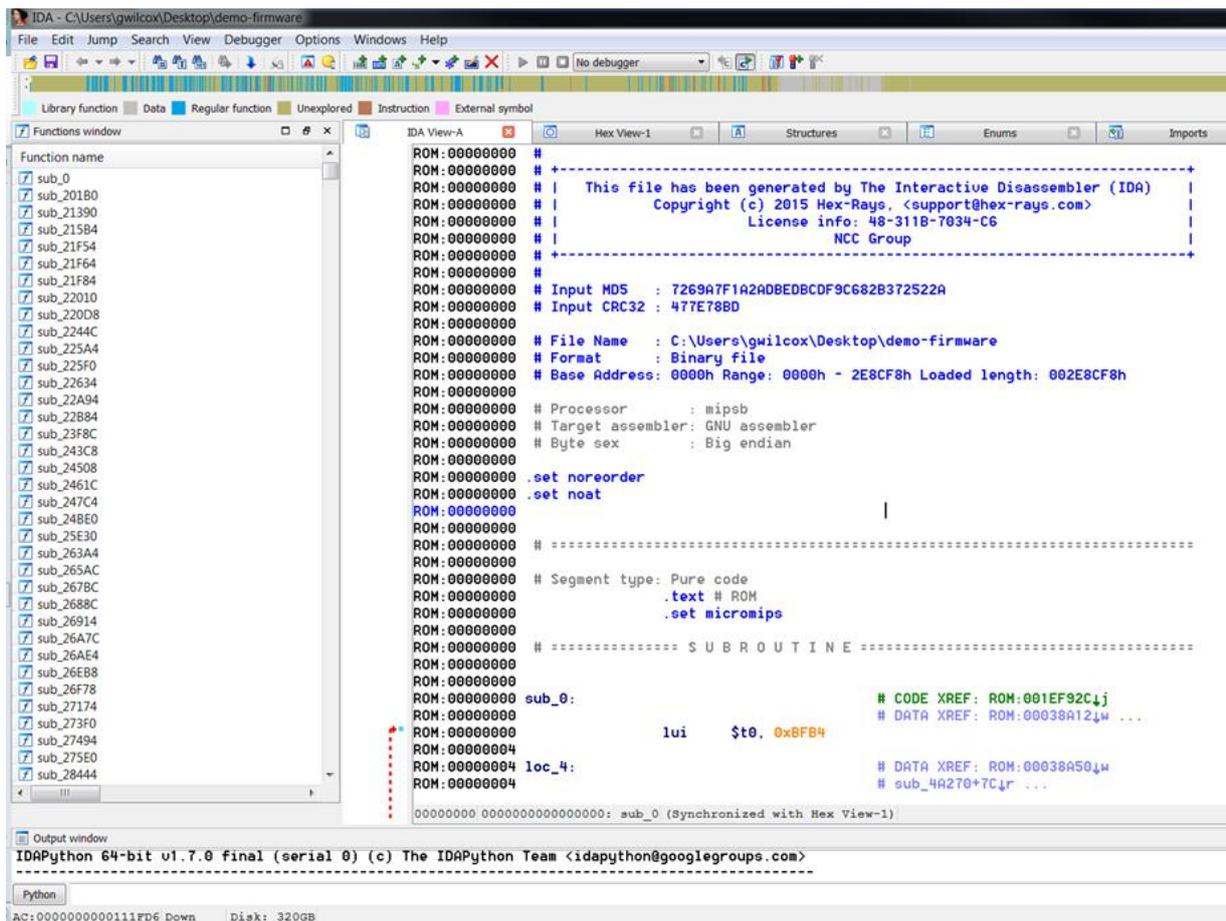
Click "OK" here, and on the next set of warnings that IDA Pro throws at us. This should take us to the following screen:

Immediately we notice a problem with IDA’s initial analysis. There are a lot of sections that IDA has marked as yellow in the navigation bar at the top. This means that IDA Pro decided to skip analysis of these sections for some reason. In order to get IDA Pro to analyse these sections, we will need to rebase the entire program to an appropriate address. Thanks to some help from Cedric Halbronn (@saidelike), I determined that the most appropriate address to rebase the program would be 0x80020000, which would make most of the firmware’s hardcoded addresses point to the correct locations in memory. (On a side note, it has been discovered that many other routers also seem to be based at this memory location, so you may wish to rebase the program to this address if IDA Pro’s initial analysis is not returning much). To rebase the program, select Edit->Segments->Rebase Program. You should see the following screen:

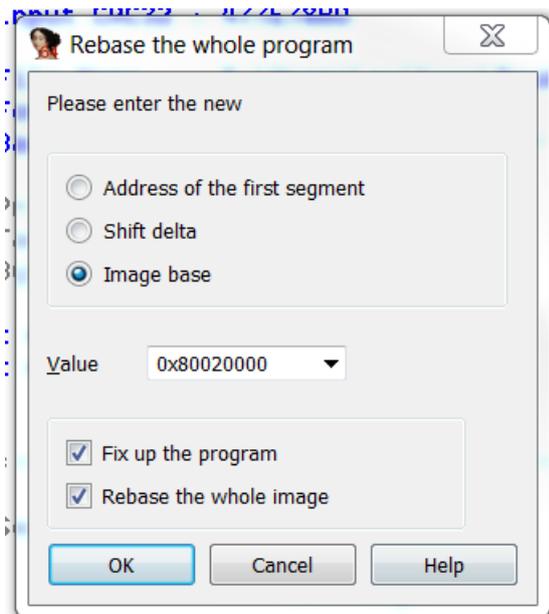
We want to enter 0x80020000 into the value box to change the base address of the image. After the change our screen should now look like this:

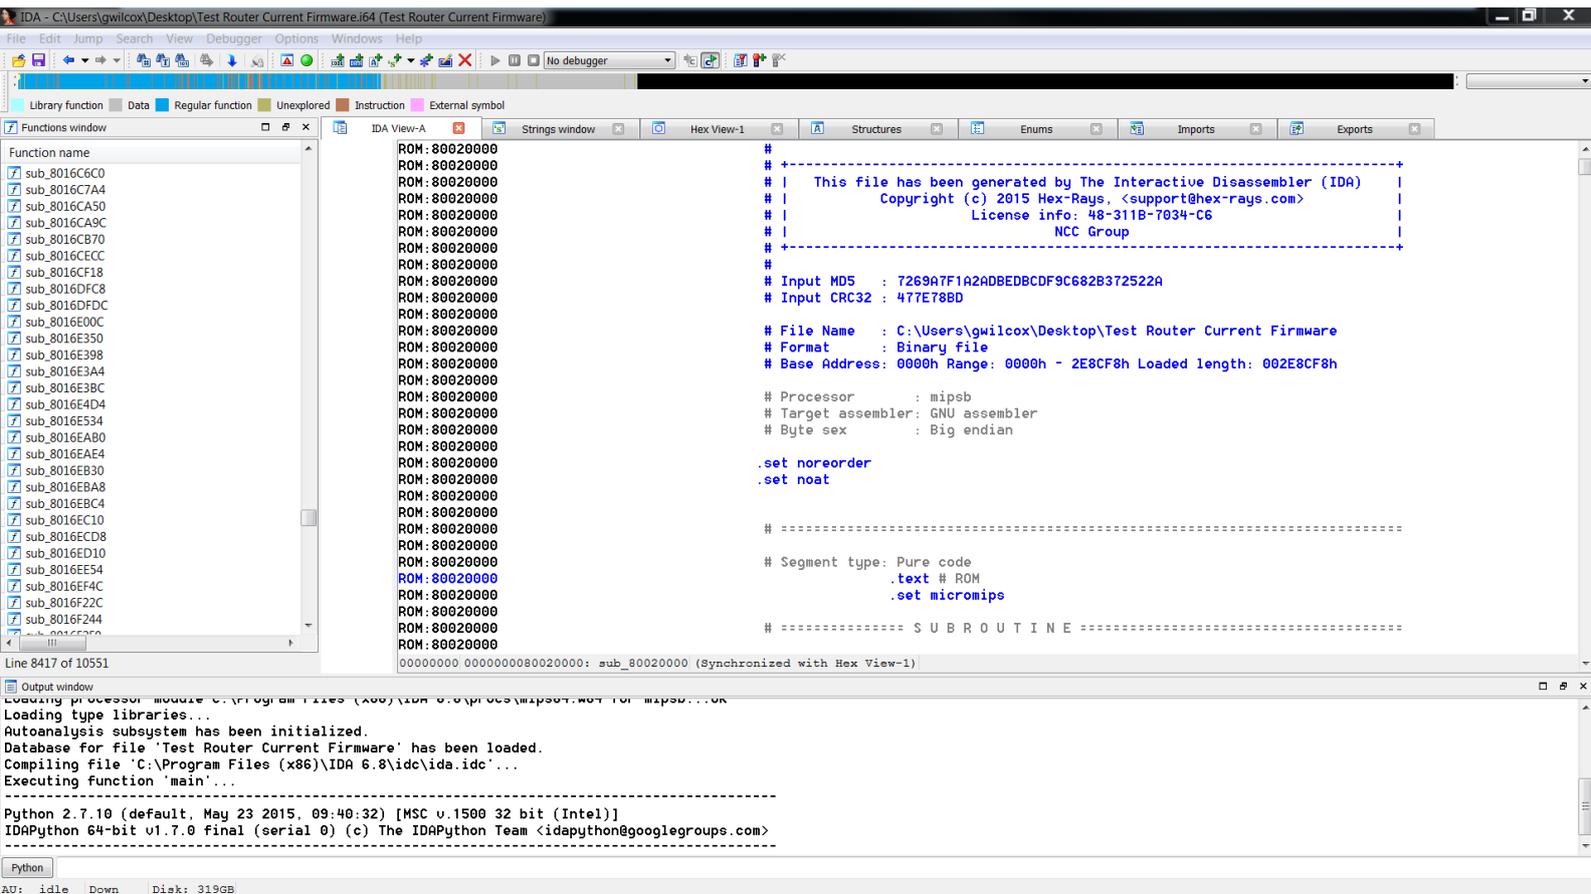
Once I had navigated through the code and had defined the required sections as code or data, I was left with an IDA database that looked like this: (notice how most of the yellow unexplored areas now show up within IDA as regular functions):

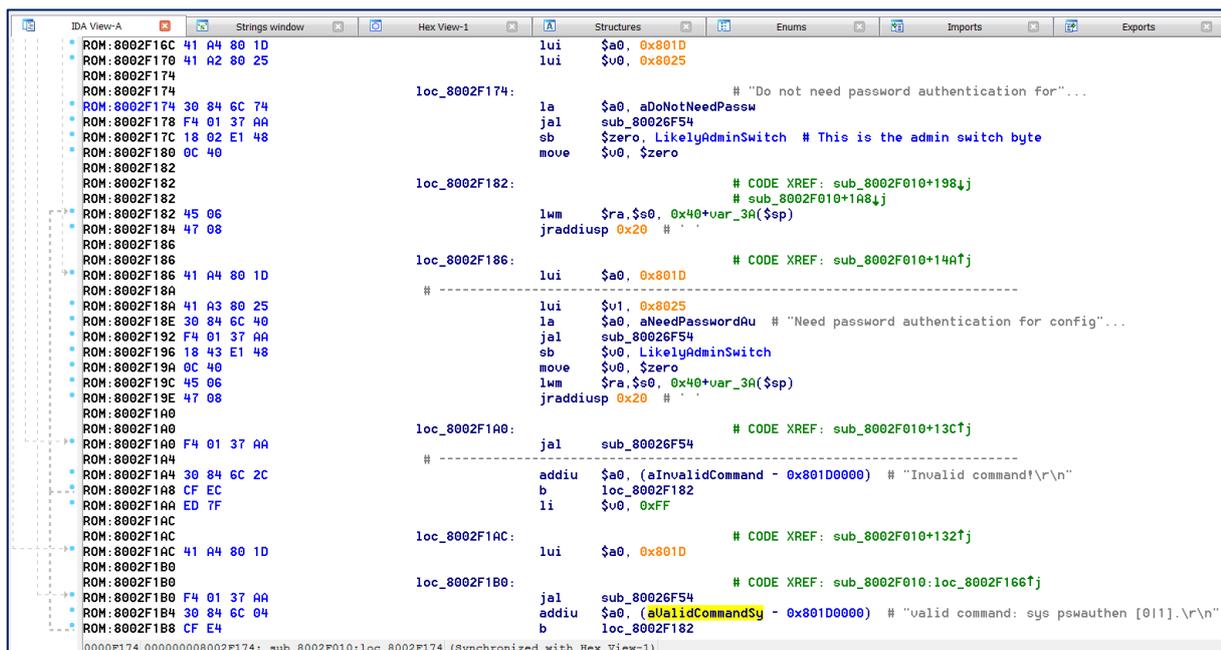
Following along with Cowan's work³, we see that the "Do not need password authentication for configuration!\r\n" string within the firmware corresponds to an built in option to toggle on/off the need for a valid username + password combination to be used to access the router's web interface. This can be seen within the firmware starting at around address 0x8002F174:

We can also see that at 0x8002F178, there is a `sb $zero, 0x8024E148` instruction. (I have renamed the address 0x8024E148 to **LikelyAdminSwitch** so that it is easier to read as we analyse this code) The instruction `sb` stands for “Store byte” in the microMIPS instruction set and will cause the byte at location 0x80204E148 to be set to the least significant byte of 0, or 0.

As we know that this block of code makes reference to the string “Do not need password authentication for configuration!”, we can be fairly sure that this code sets the byte at location 0x80204E148 to 0 to disable the need for password authentication to access the router’s web interface.

Correspondingly, if we look at the block of code starting at 0x8002F186, we can see that we first load some base addresses into `$a0` and `$v1`, and then a reference is made to the string “Need password authentication for configuration!” A jump is then made to `sub_80026F54`, which we can conclude is probably a call to `printf` or something similar to print the message out to the screen. Following this we see that 0x80204E148 (the address of **LikelyAdminSwitch**) is set to the least significant bit of `$v0`. While we are not aware of the value of `$v0`, it seems likely that since 0x80204E148 is set to 1 by default, as can be seen in the screenshot below, `$v0` will contain 1 to set it back to its original value:

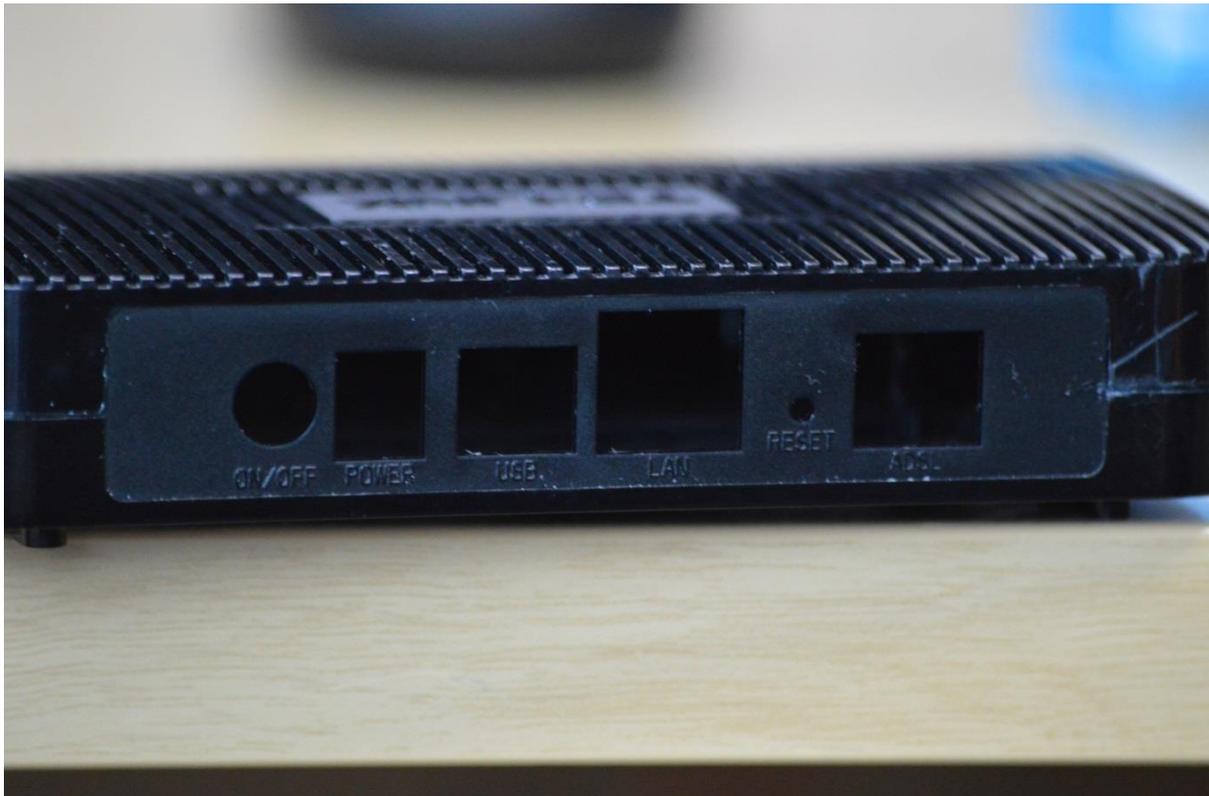
Next, find the back of the case. It should look similar to this:

This part is especially tricky to do, even after you get the board open the first time. What you'll want to do is look at where the scratches are on the board above, right on the gap between the two pieces of plastic. If you look on the left side of the image, to the left of the ON/OFF power button, you'll see there is a similar gap between the two pieces of plastic. You need to crack open both sides of the board by using your fingernails or a flat-headed screwdriver to forcibly open these gaps wide enough, and keep prying them open on both sides until the top part of the casing comes off and you are left with the bottom part of the casing and the board itself:

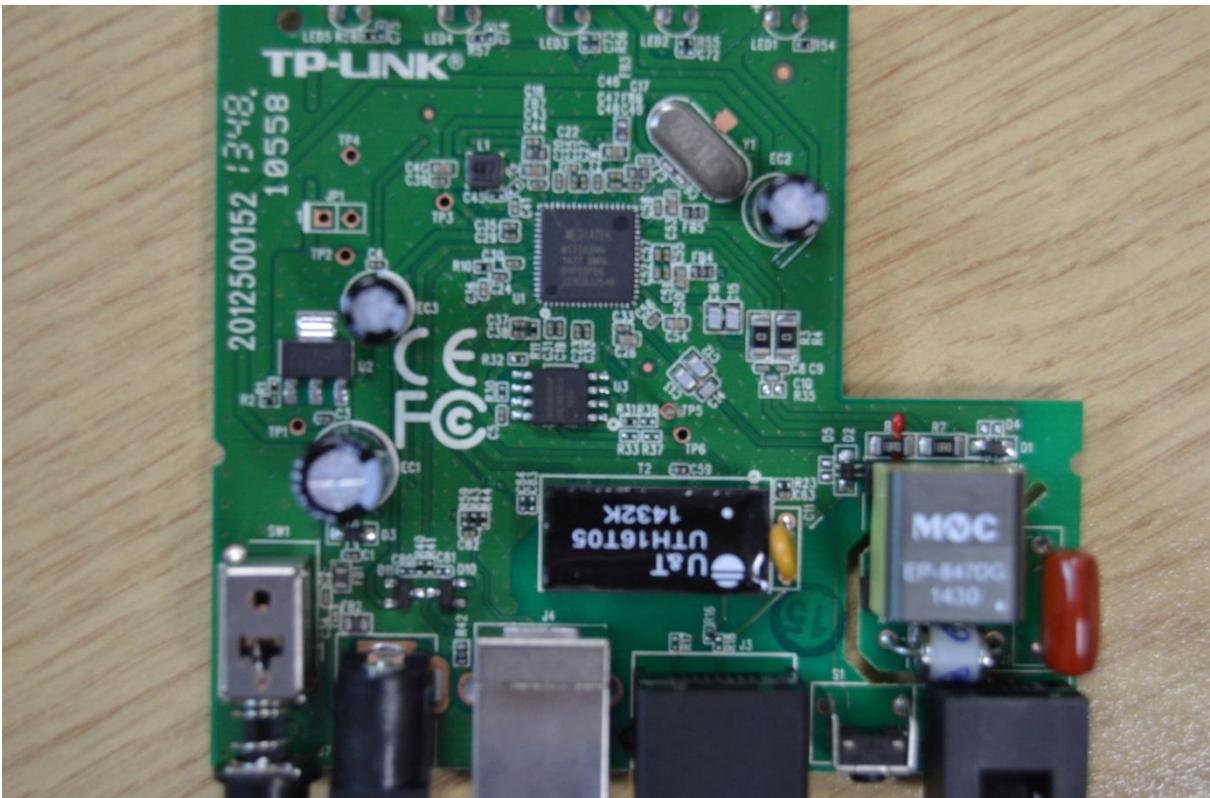
Carefully pull the back of the board up then pull it away from you (aka away from the back of the router and the plastic casing for the buttons). You should now be left with the board itself:

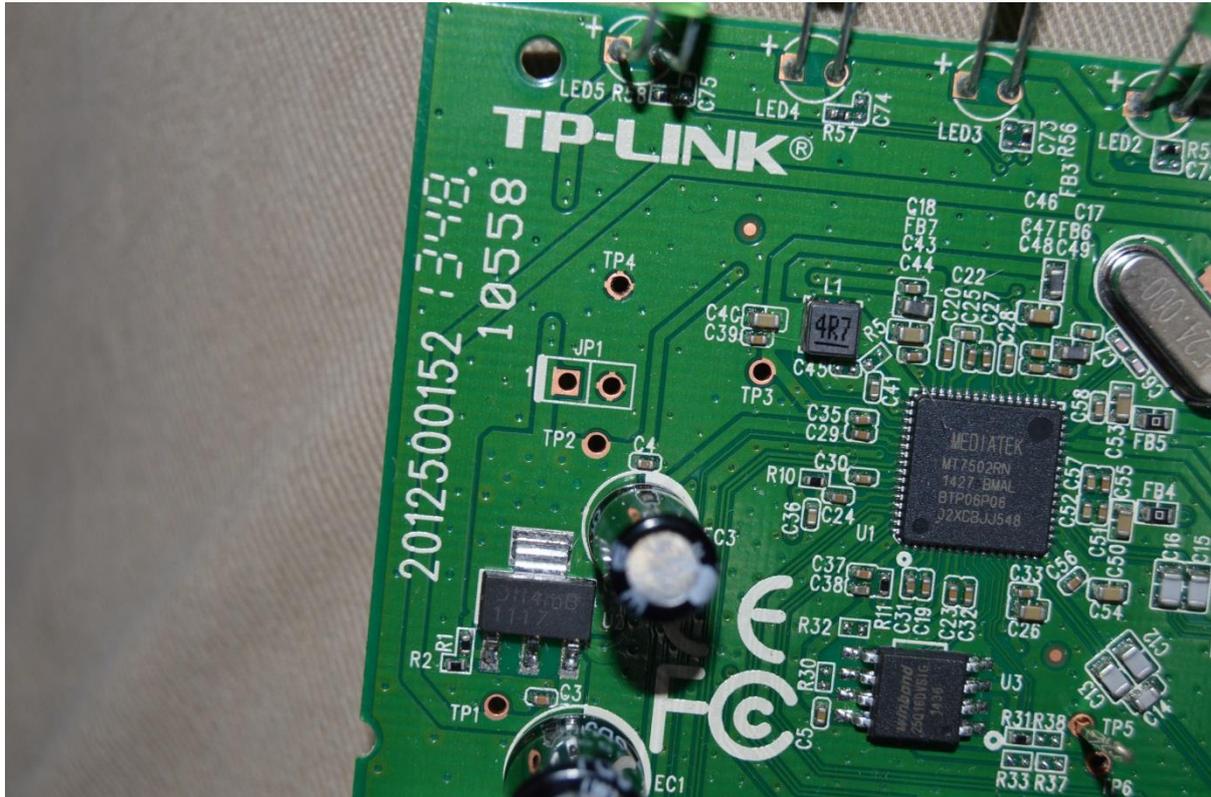
If you look carefully at the board you will see that there are a number of round holes on the board, numbered TP1 to TP6. Starting with TP1 to TP4:

Now that we have identified some candidate pins (TP0 to TP6), we need to figure out what the purpose of each one is. For this, I would recommend that you reference the excellent guide on identifying serial ports by devtys0⁴.

You should be able to find that TP4 is the ground port by touching TP4 with one of the voltmeter's probes and the metal shielding of the Ethernet port with the other, powering on the router, and seeing that the voltmeter gives a volt reading of 0, or no current running through the device.

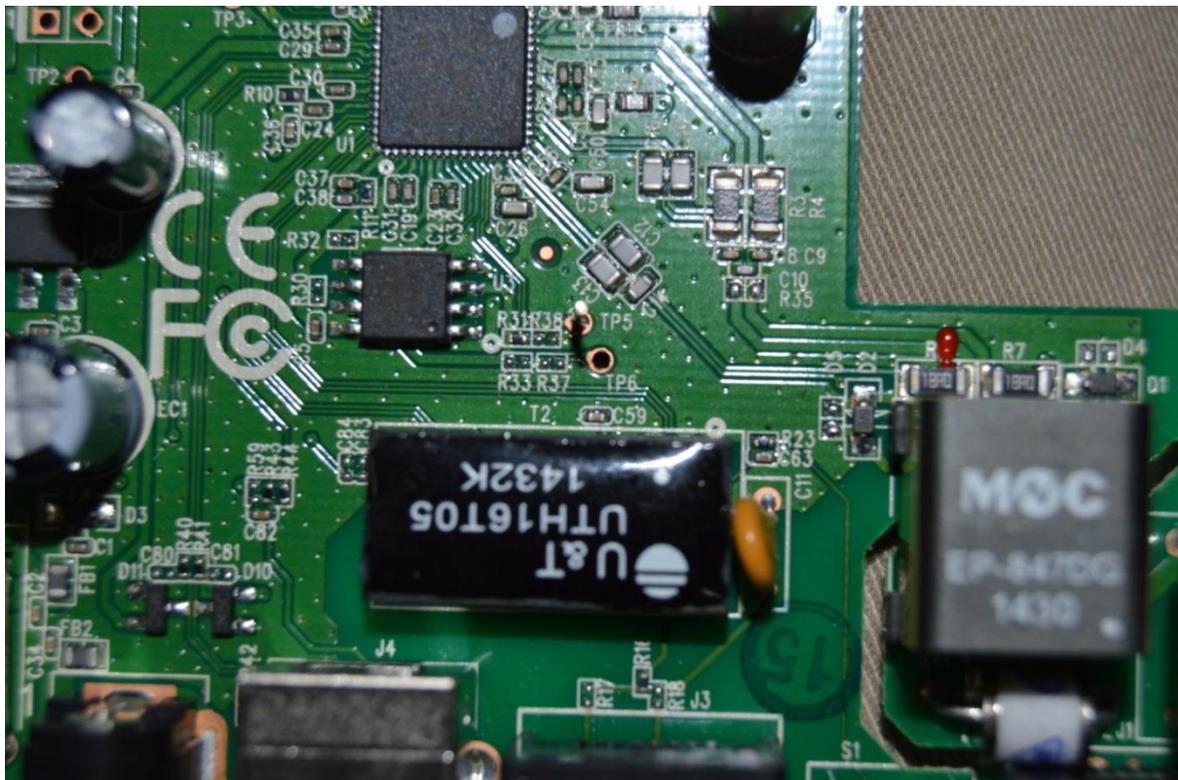
And now TP5 and TP6 (Please ignore the pin already soldered into TP5. That was my work not TP-LINK's):

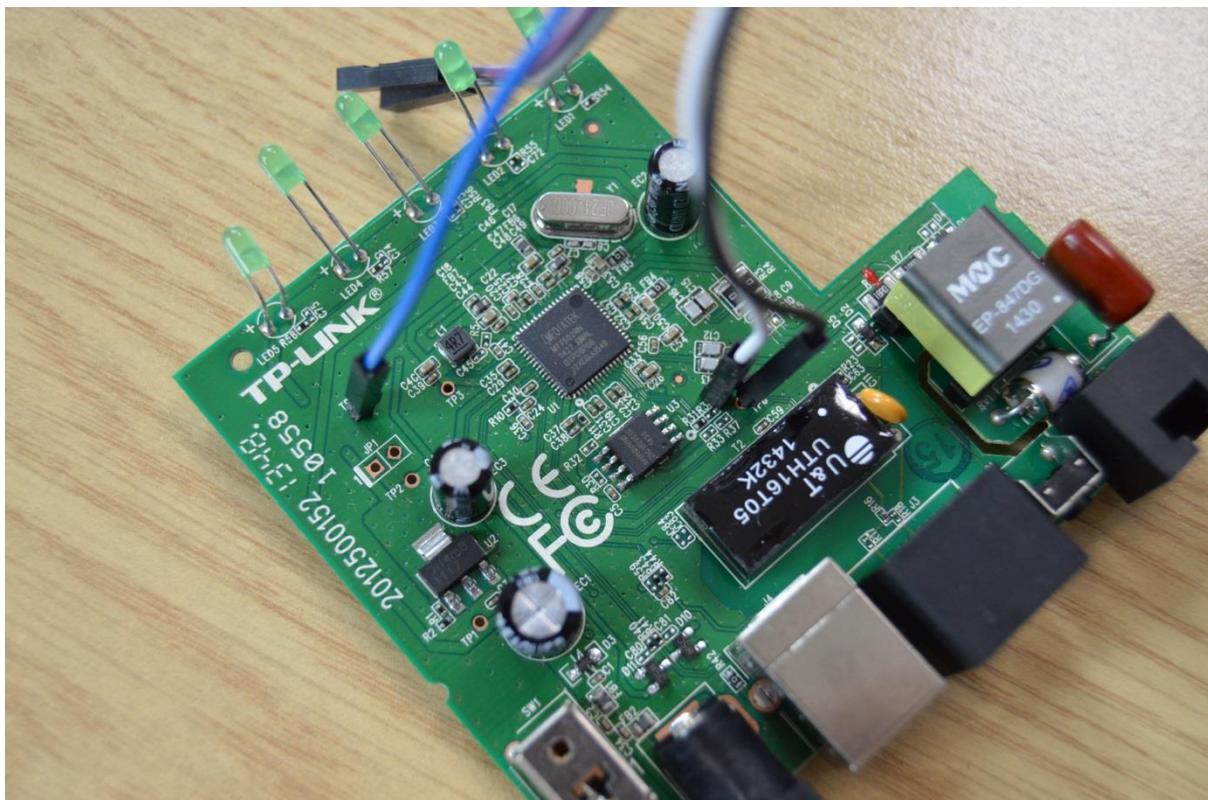
Now that we have identified the ports, we need to connect the USB to TTY serial adapter to the board. To begin with, cut off three breakaway pins from the set that you have brought and solder them into TP4, TP5 and TP6. You may find you need someone to hold the board while you solder, as the pins have a tendency to fall out of their holes quite easily. Once you have soldered the breakaway pins in, connect three of your jumper wires onto the pins and take note of which colour wire corresponds to which port. In my case I used the blue wire for TP4, or the ground, black for the receive port, or TP6, and white for TP5, or the transmit port:

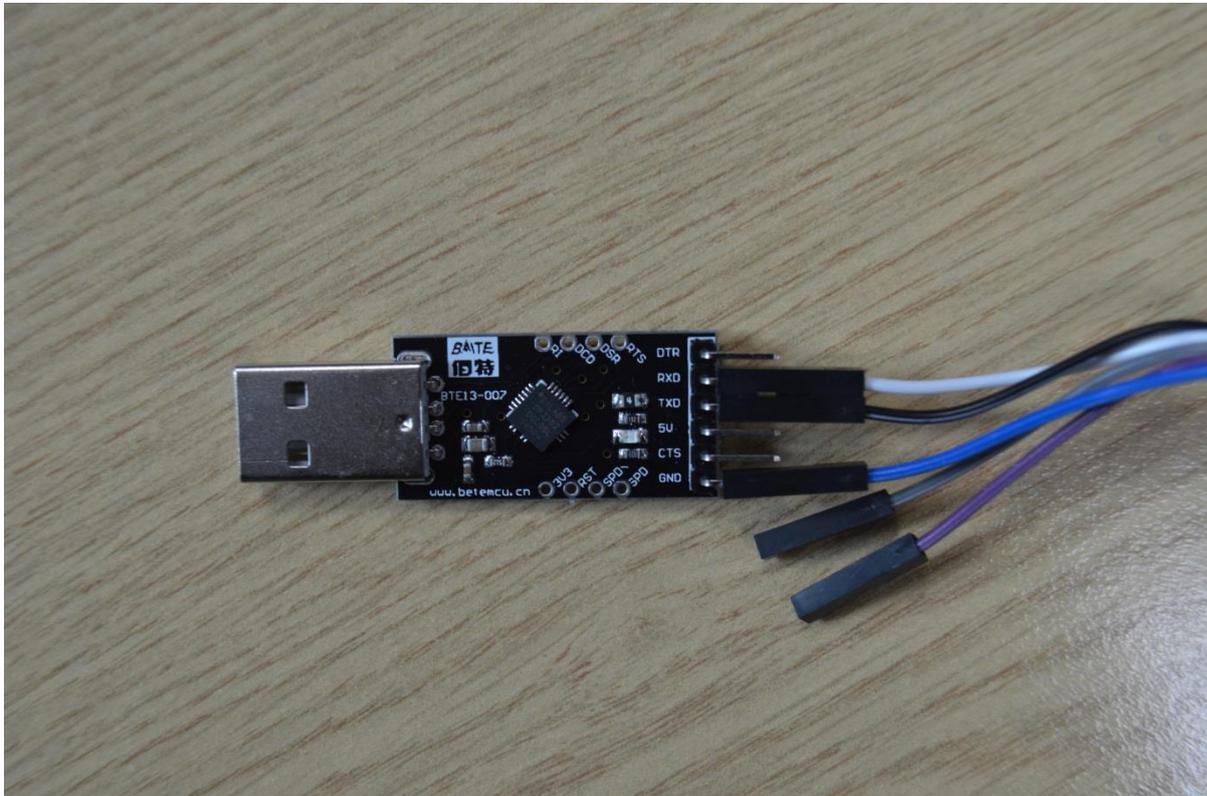
On the USB end, we will need to switch things up slightly. The ground wire will still be the same, so connect the same cable that you used for the ground (blue in my case) to the pin labelled “GND” on the USB adapter. However, when you get to the data ports, we will need to switch them around. Remember that whatever we *transmit* from one computer needs to be *received* by the other. Therefore we will connect our black receive line from the board into the “TXD”, or transmit, port on the USB adapter, and we will connect our white transmit line from the board into the “RXD”, or receive, port on the USB adapter:

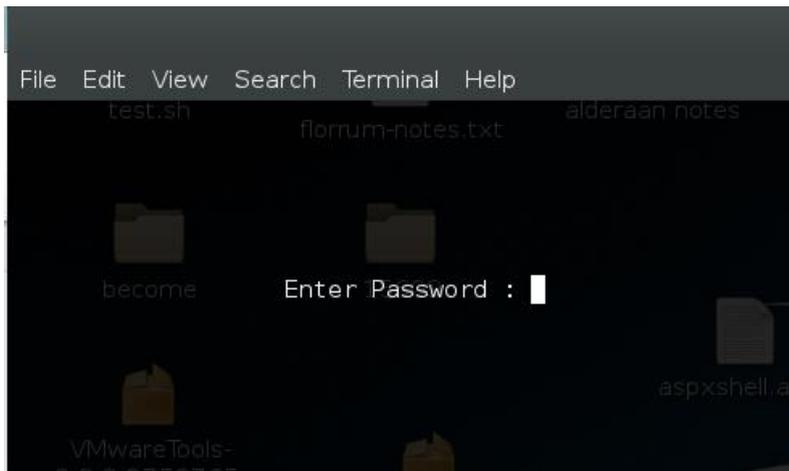
If you press “enter”, you should get a prompt asking you to enter a password:

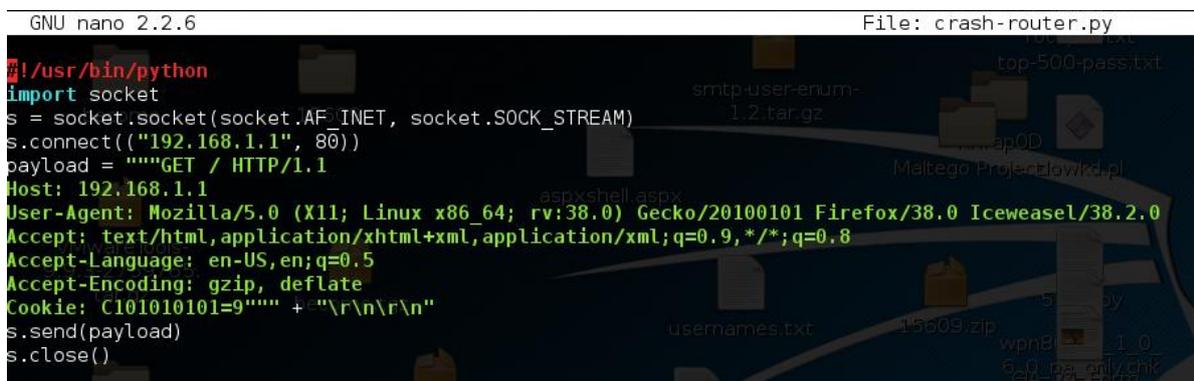
With our serial/debugging line into the router set up, let’s try crashing the router once again and seeing what debugging information we can acquire. For reference, here is the file that we created earlier, which we will use to crash the router:

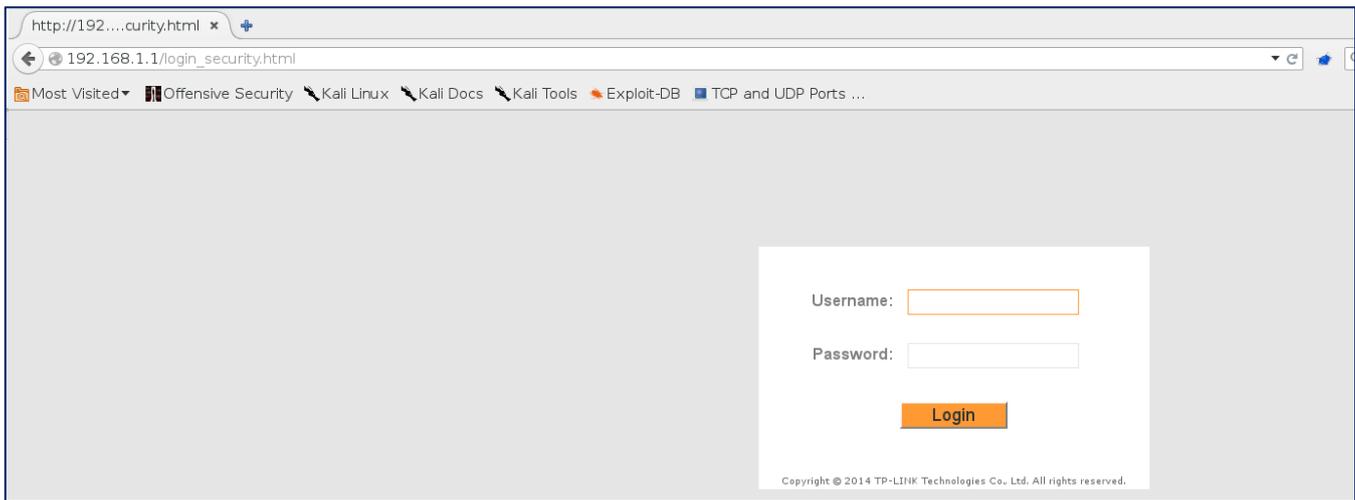
Let's test this out against the router. To start, we will make a request to the router's IP address (192.168.1.1) normally:

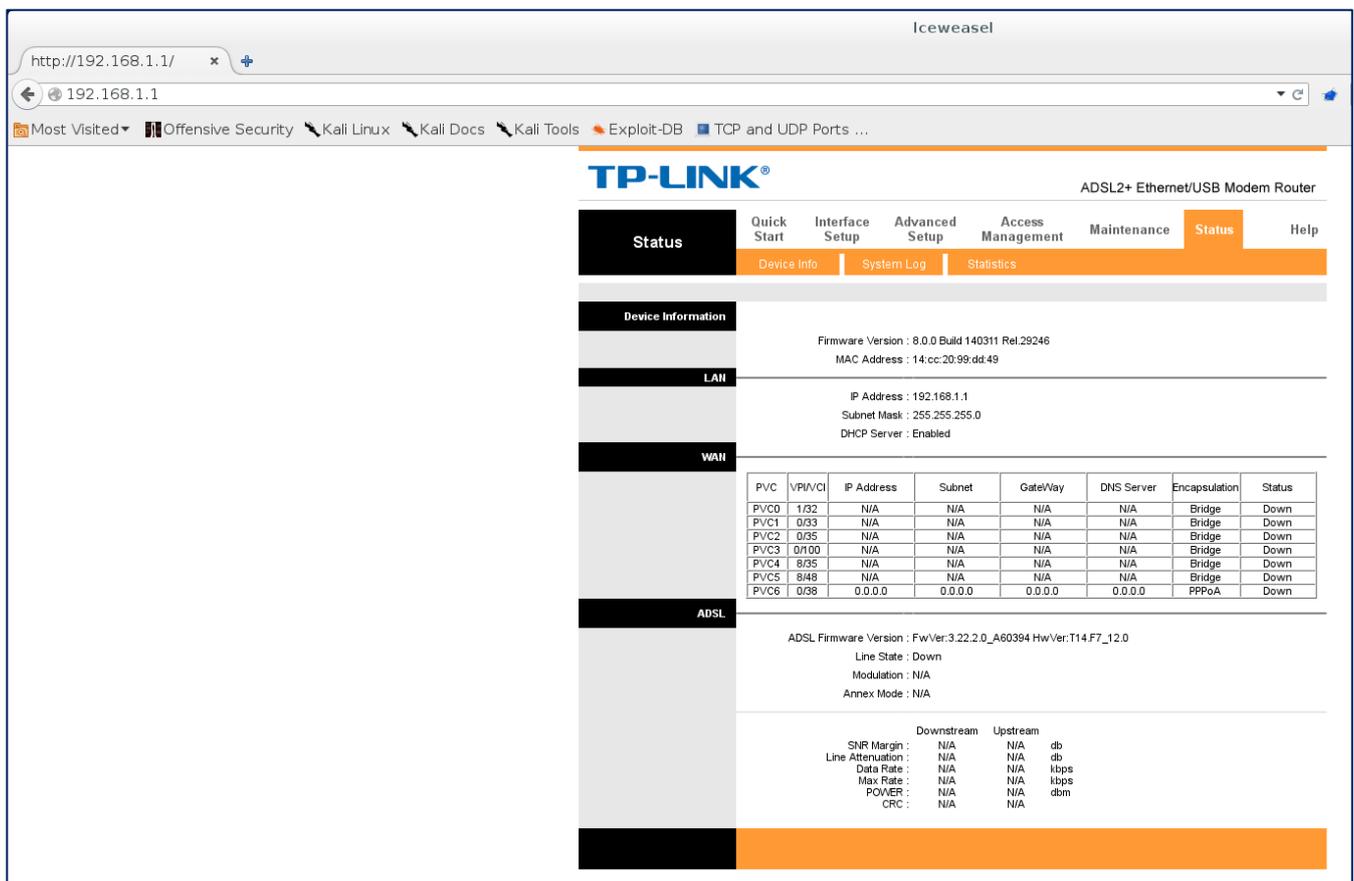
As you can see, we are prevented from accessing the page and are instead redirected to the login page at /login_security.html. If we run our Python script and try accessing 192.168.1.1 normally once again:

We can see that we have gained access into the router.
